LEE E. HARRIS, Ph.D., P.E.

Consulting Engineer

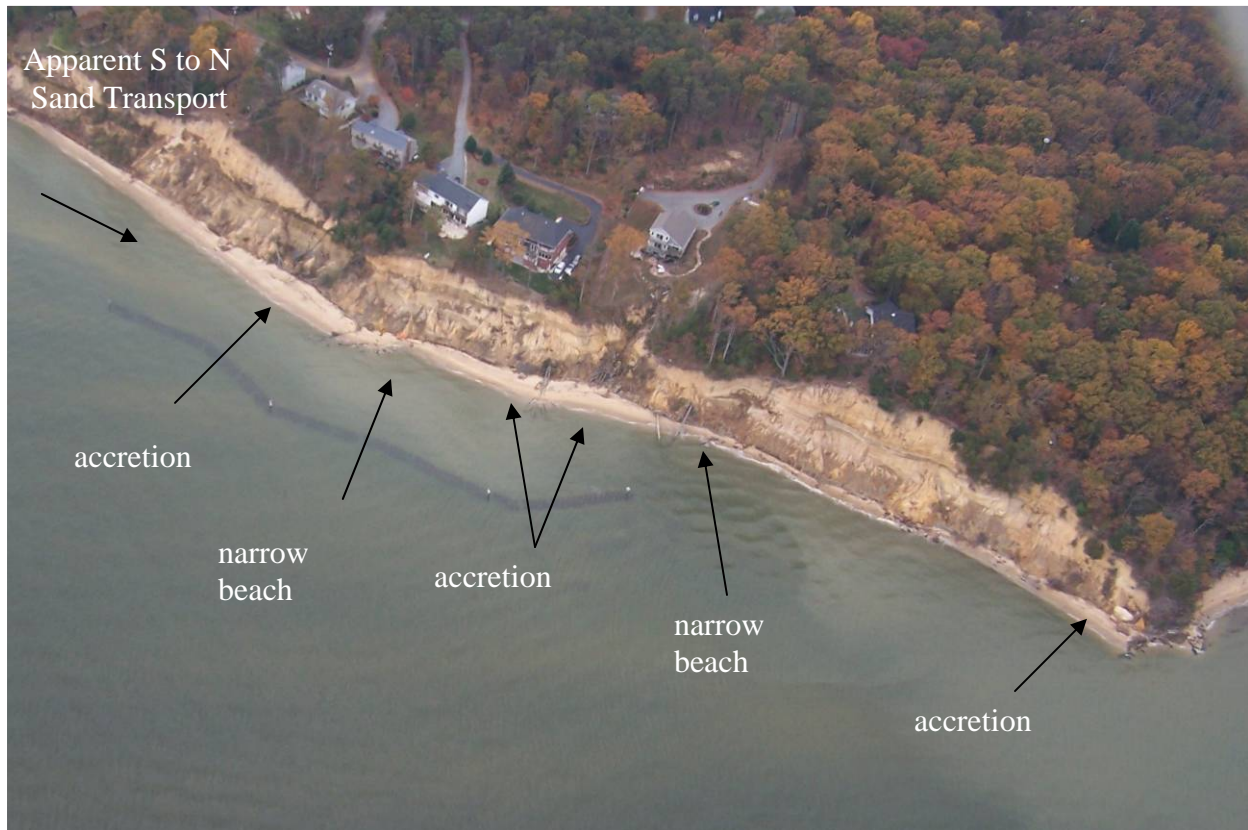
Photograph above shows apparent south to north (left to right) sediment transport, with downed trees and rock headlands acting as groins (see also photo on next page).

Note the accretion behind the breakwater (also shown in our last survey), except for the one narrow beach area. This narrow area may be due to sand trapping by the downed trees to the south acting as a groin.

The above photograph may only show seasonal conditions, with possible longshore sand transport reversal at other times of the year.

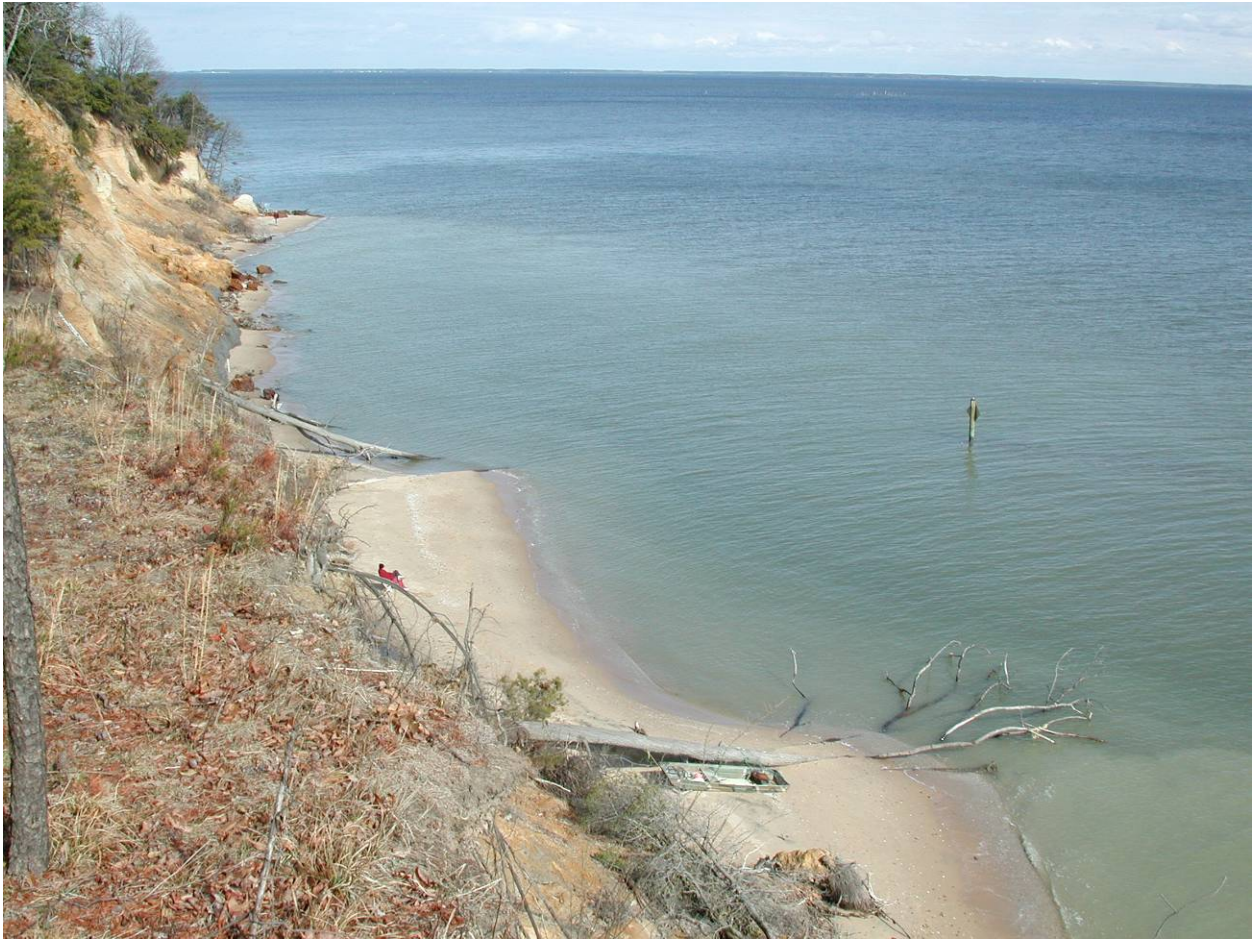
Photograph above shows downed trees and rock headlands acting as groins, indicating apparent south to north sand transport (see also the aerial photograph on previous page). This longshore transport may vary seasonally or with different storm events.

Post in water marks the northern end of the Reef Ball breakwater.
