STATUS REPORT FOR THE SUBMERGED REEF BALL™ ARTIFICIAL REEF BEACH STABILIZATION PROJECT FOR THE GRAND CAYMAN MARRIOTT HOTEL

performed by Lee E. Harris, Ph.D., P.E.
Consulting Coastal Engineer
Assoc. Professor of Ocean Engineering
Florida Institute of Technology
Melbourne, Florida 32901 USA

July 2002

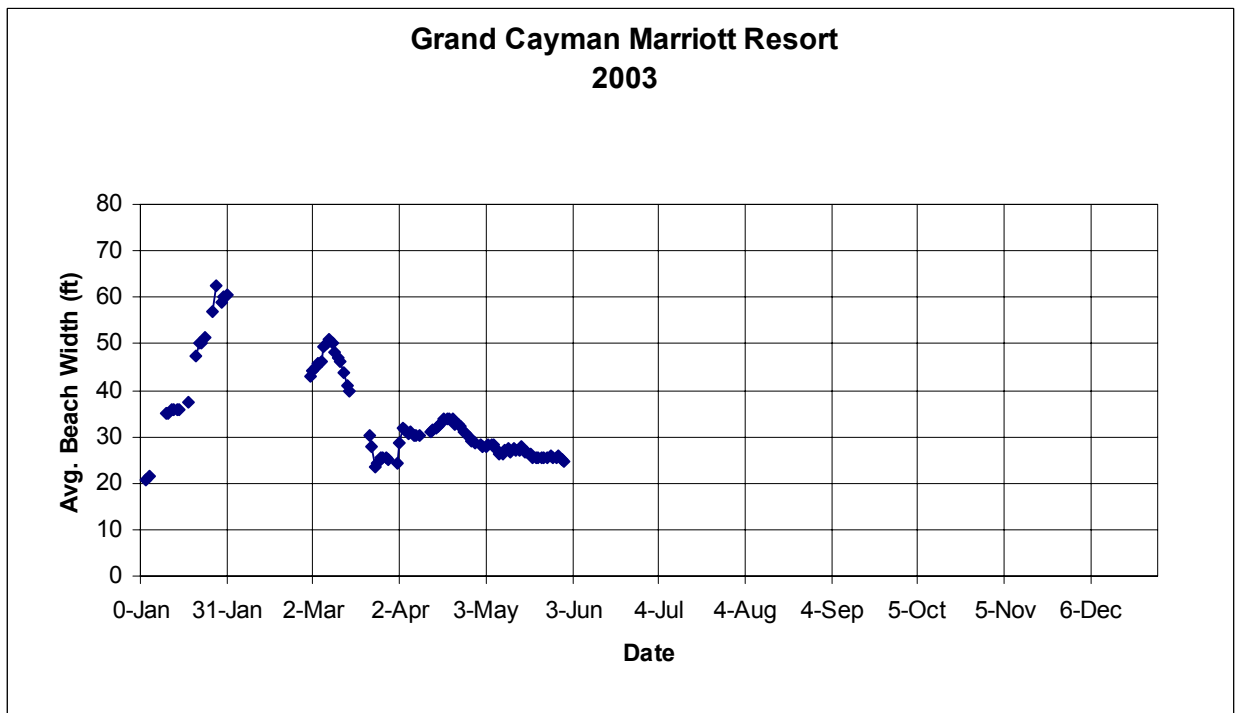
The Grand Cayman Marriott Resort has experienced beach erosion. The existing beach width varies seasonally and with storm events, and although it does begin to recover by sand transport into the area from the north, the beach continues to be eroded away by waves coming from the southwest each fall. The staff at the Marriott measures the beach width from the seawall at the north, center and south end of the property every day, with this information providing a good record of beach changes, and should be continued to be collected. These data are shown in the graphs below for the variation in the average beach width in front of the Marriott over time:

Note that these graphs show that there are seasonal changes in the beach width, but prior to the installation of the Reef Ball breakwater at the end of 2002, the beach width was decreasing each year. In 2002 the maximum beach width was only 45 feet and the minimum width was zero, and the zero beach width occurred over a much greater time period than in prior years. Following the installation of the Reef Ball breakwater (completed at the end of 2002) the data to date for 2003 show that the beach width reached a width in excess of 60 feet, with the minimum width of 25

feet. The fall tropical storm and hurricane season has the narrowest beach widths, which may reduce the existing beach width further.

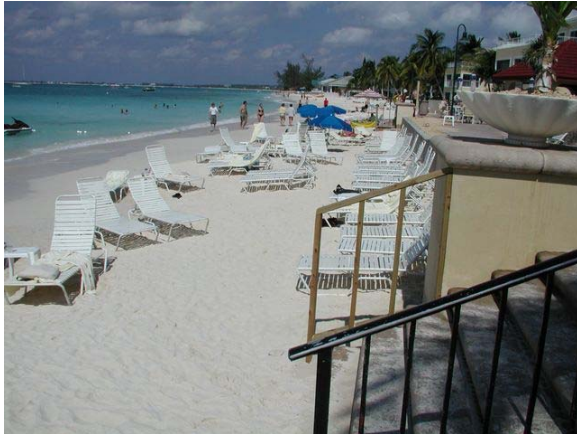
View North:

The photographs below show the condition of the beach in February 2003, which increased in width from zero to over sixty feet wide following the installation of the Reef Ball breakwater. Over 200 Reef Ball units were installed in the design template, with top elevations near but below the normal low tide elevation as was designed and permitted.

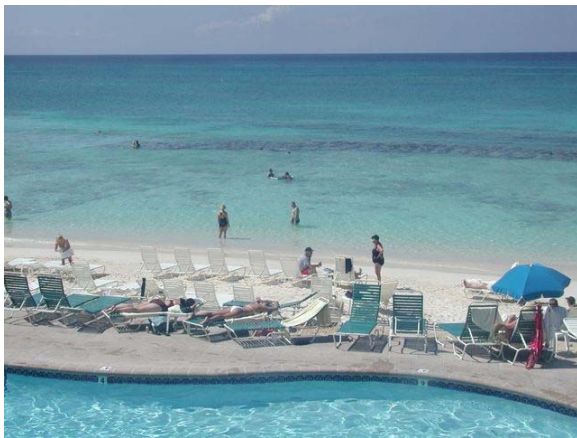
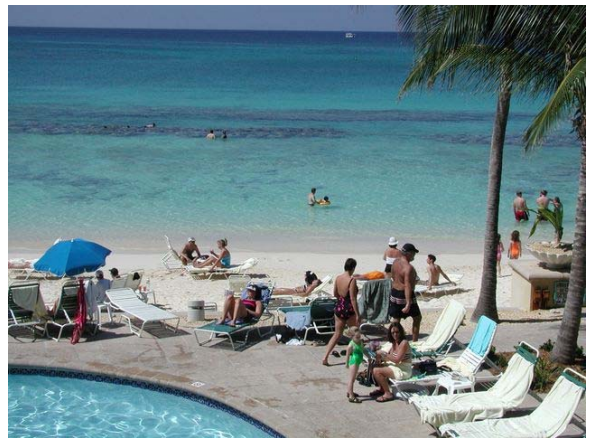
The photographs below taken in February 2003 show the offshore Reef Ball breakwater:

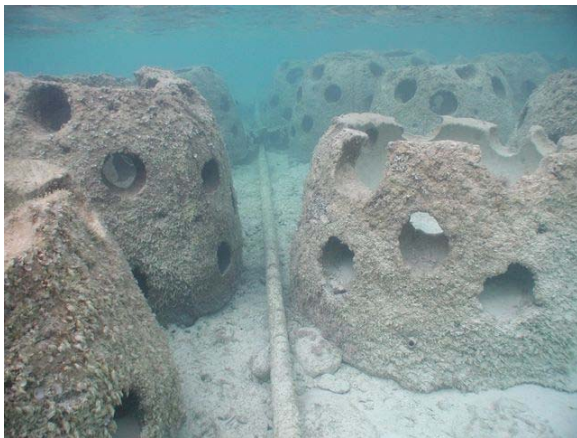
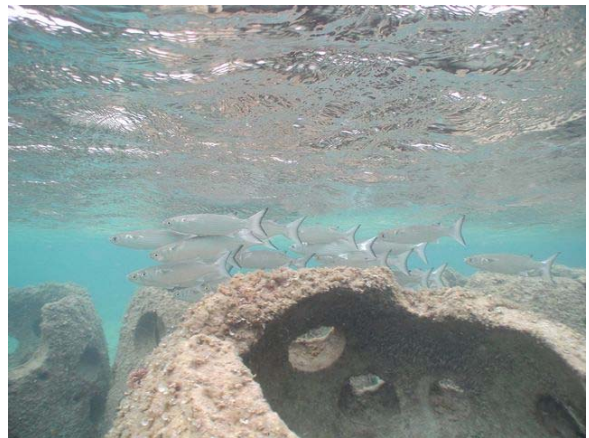
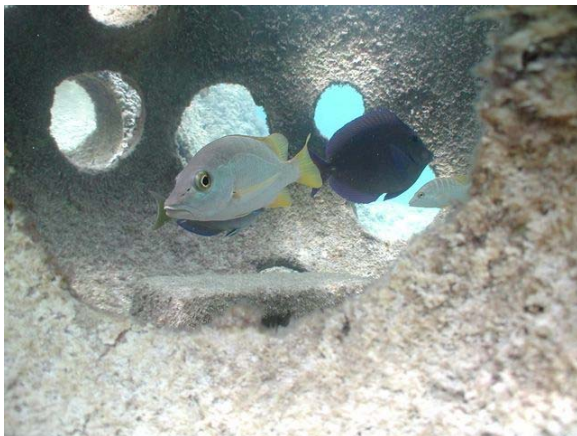
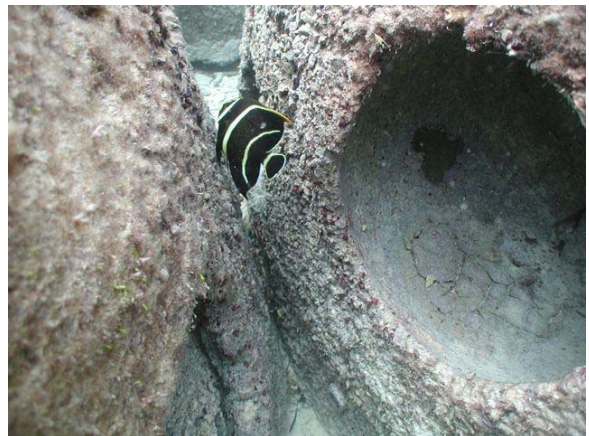
The underwater photographs below show the condition of the Reef Ball units. After only 3 months, there is considerable marine growth on the Reef Ball units and several species of fish in and around the artificial reef units. Note that some of the Reef Ball units had to be fabricated shorter than the standard size, due to the shallower water depths at the south end of the breakwater.
