***Options for Improving the Beach for  
J.W. Marriott and Casa Magna Resorts  
Cancun, Q.R., Mexico***

by Lee E. Harris, Ph.D., P.E.  
Consulting Coastal and Oceanographic Engineer  
Associate Professor of Ocean Engineering  
Florida Institute of Technology  
Melbourne, Florida USA

November 2007

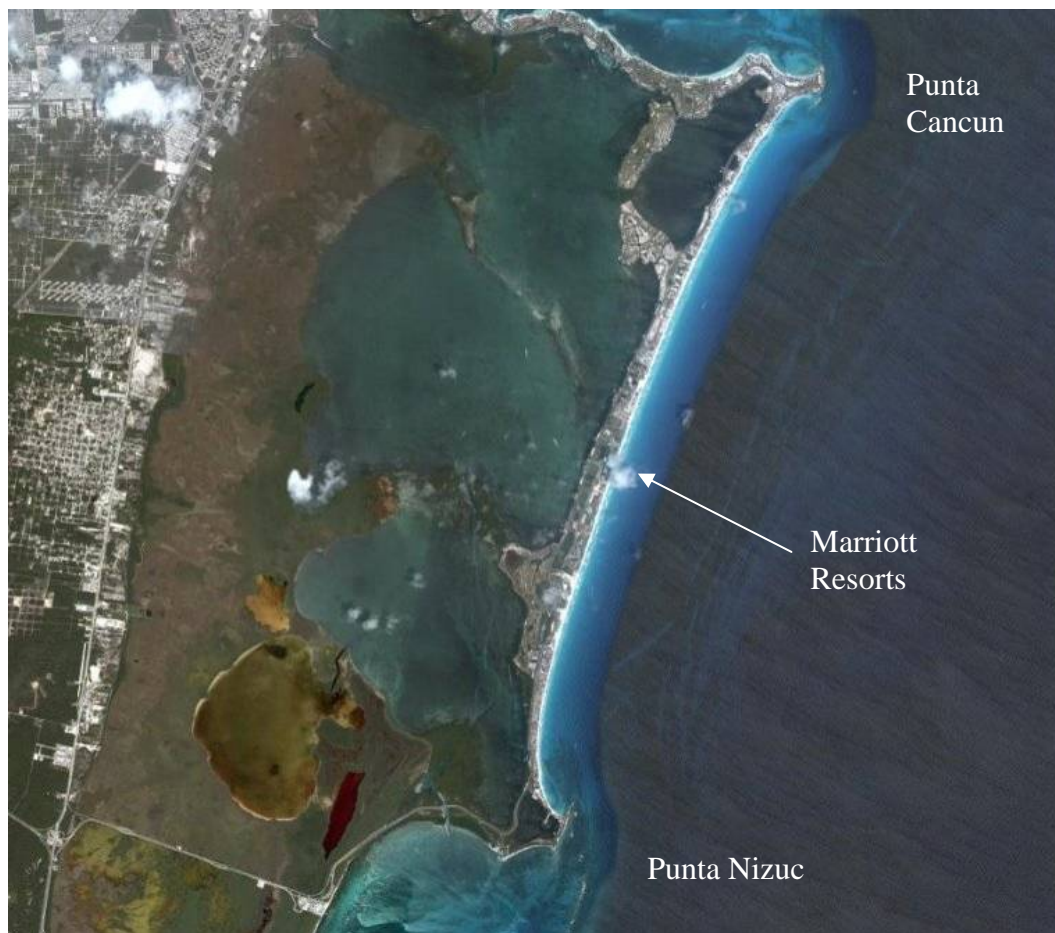
**Figure 1. Cancun Coast with Location of Marriott Resorts (Google Earth)**

The J.W. Marriott and Casa Magna Resorts are side-by-side, and are located near the center of the eastern coast of Cancun, Mexico. Figure 1 shows the Cancun coastal area plotted in Google Earth, with the project location shown in Figure 2.

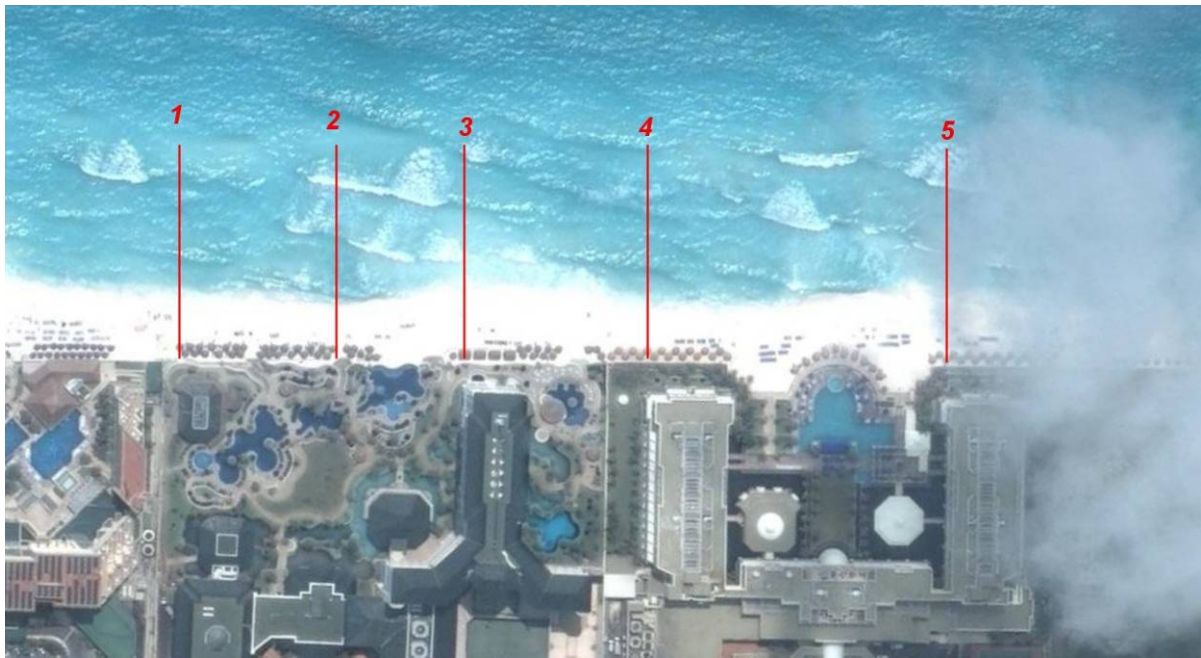
**Figure 4. Five Beach Profiles surveyed in November 2007**

Surveys of the J.W. Marriott and Casa Magna Marriott beaches and nearshore area were performed on 9 and 10 November 2007. Five profile lines were surveyed from the existing seawall out to a water depth of 11 to 12 feet (almost 4m). Figure 4 shows the locations of the profile lines. Table 1 summarizes the survey data for the existing beach, with

upper beach widths that ranged from 15 to 20 feet seaward of the seawall, and distances from seawall to the water ranging from 35 to 60 feet at the time of the survey.

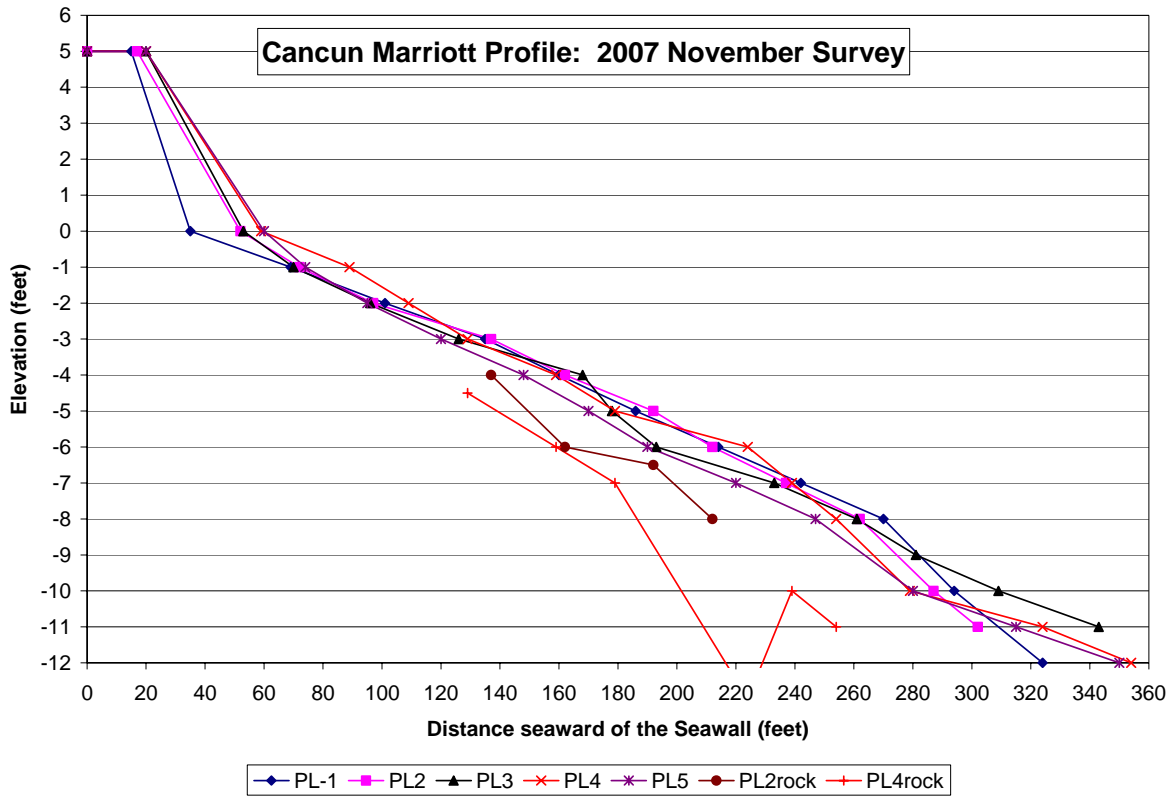
Figure 5. Graph of Beach Profile data and Jet Probes

Figure 5 shows a graph of the five profile lines including the jet probes that were performed along PL-2 and PL-4 to determine the sand depth above underlying rock in the offshore area in which a breakwater may be considered. Sand thickness varied from 1 to over 6 feet in water depths from 3 to 8 feet. More detailed surveys of the sand thickness over the rock may be required for the consideration of offshore breakwaters discussed later.

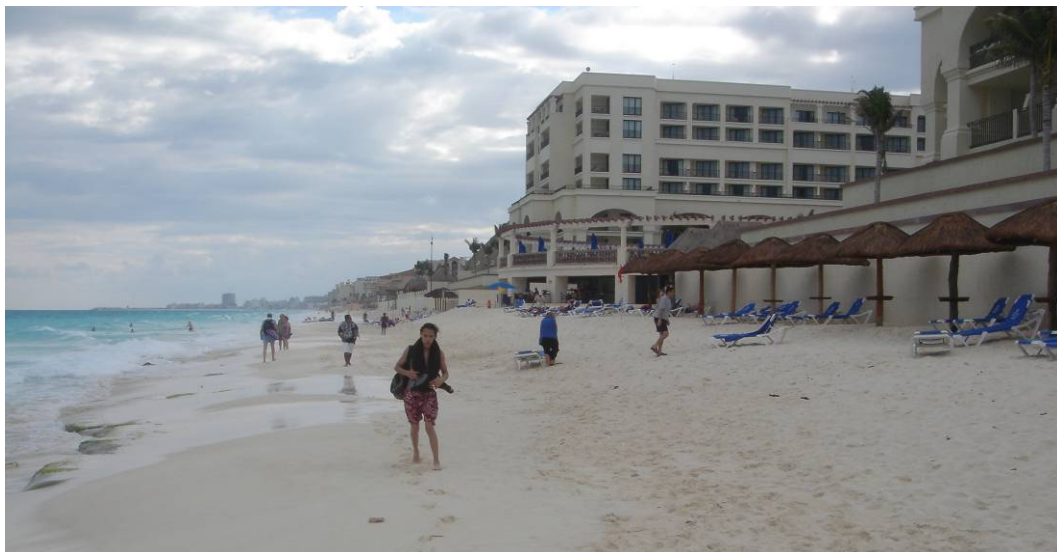
Figure 6. Exposed natural rock at water's edge offshore of the Casa Magna Marriott.

Exposure of natural rock was observed at the water's edge in the center region of the two properties, as shown in the photograph in Figure 6.

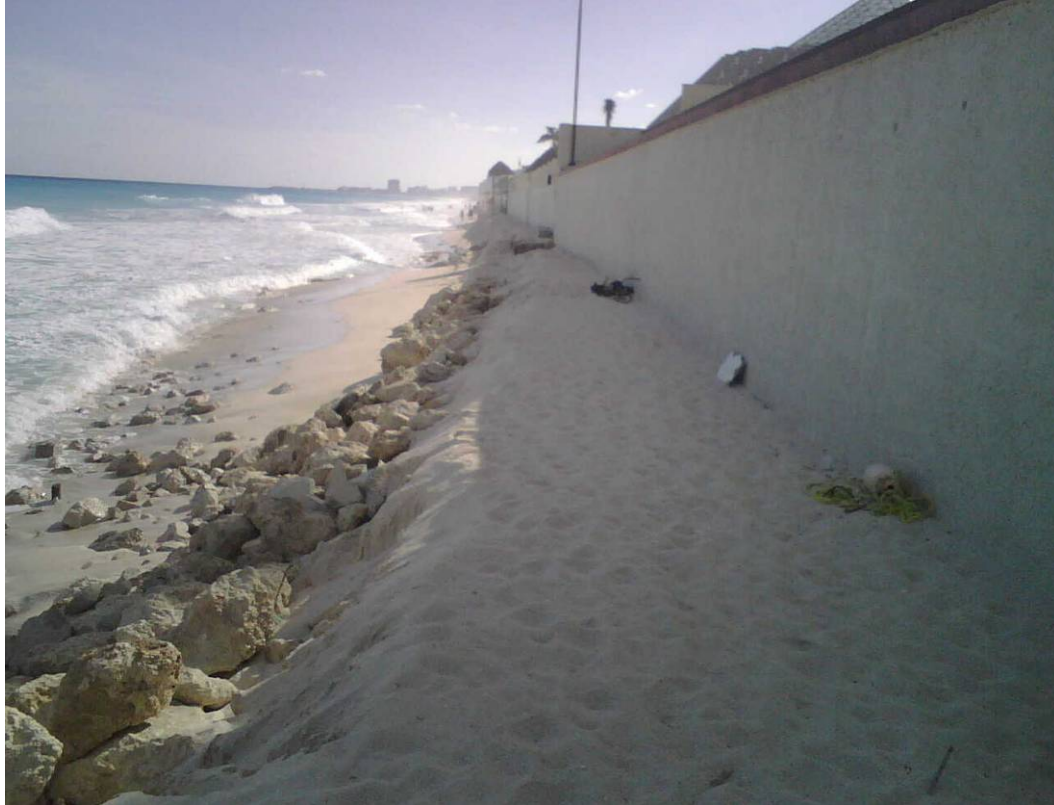
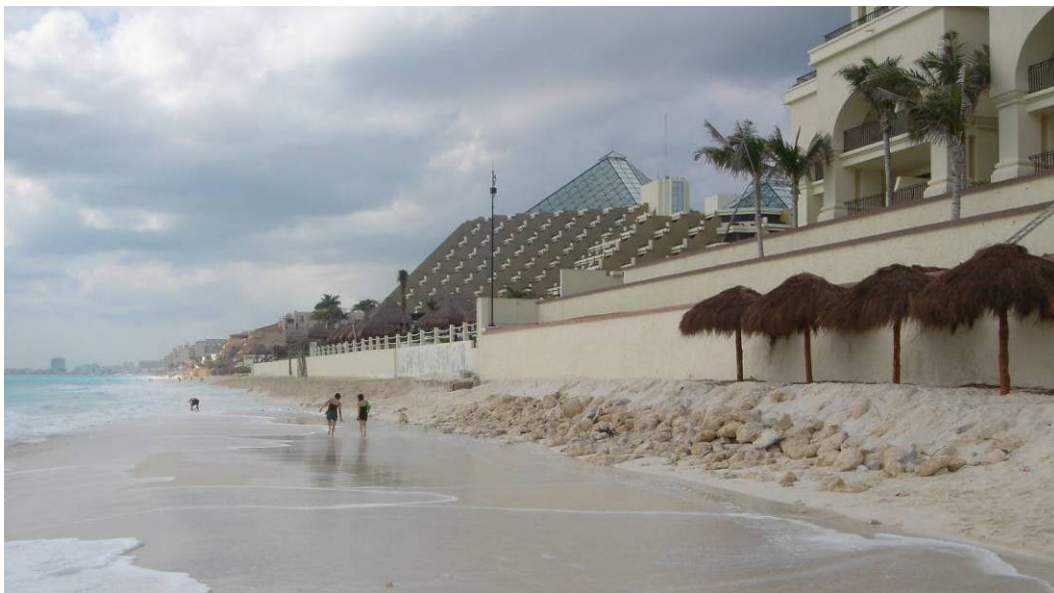
**Figure 7. South end of Casa Magna Marriott Resort – Photo dates November 2007**

Due to the continued erosion of the beach seaward of the seawall, rocks have been placed on the beach along the two properties, as shown in the photographs in Figure 7. The sizes of these rocks are not sufficient for them to remain stable, with the smaller rocks being transported down the beach (discussed in more detail later).

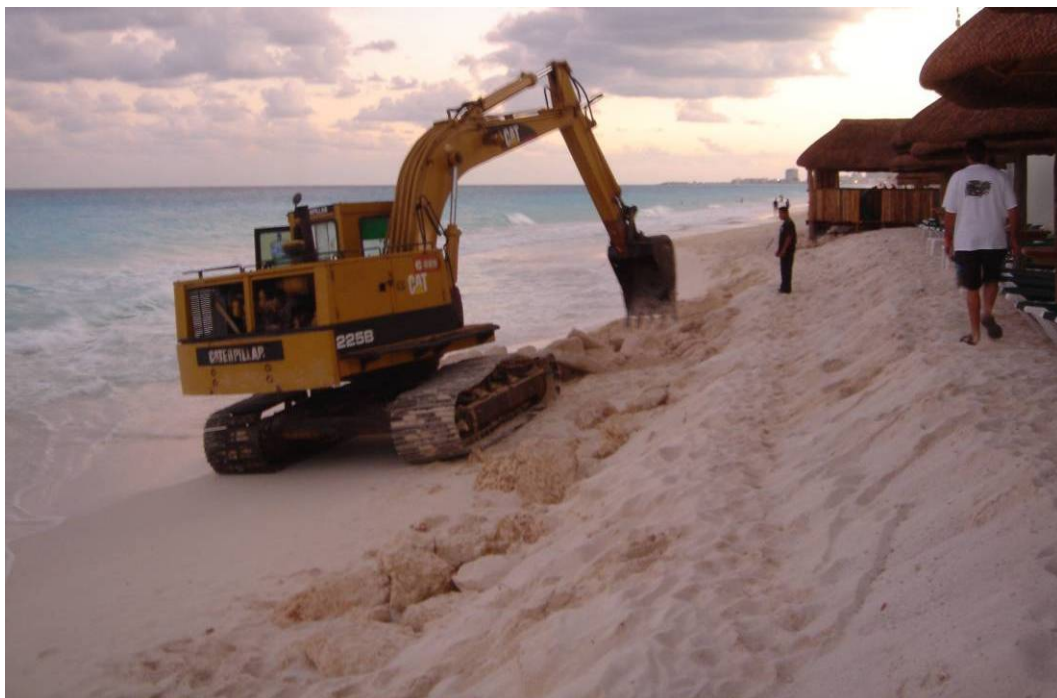
**Figure 8. Rock Removal Seaward of J.W. Marriott on 9 November 2007**

Removal of some of these rocks was performed seaward of the J.W. Marriott Resort in November 2007, as shown in Figure 8. The proper design and installation of rocks for toe scour protection for the seawall is discussed in the next section.

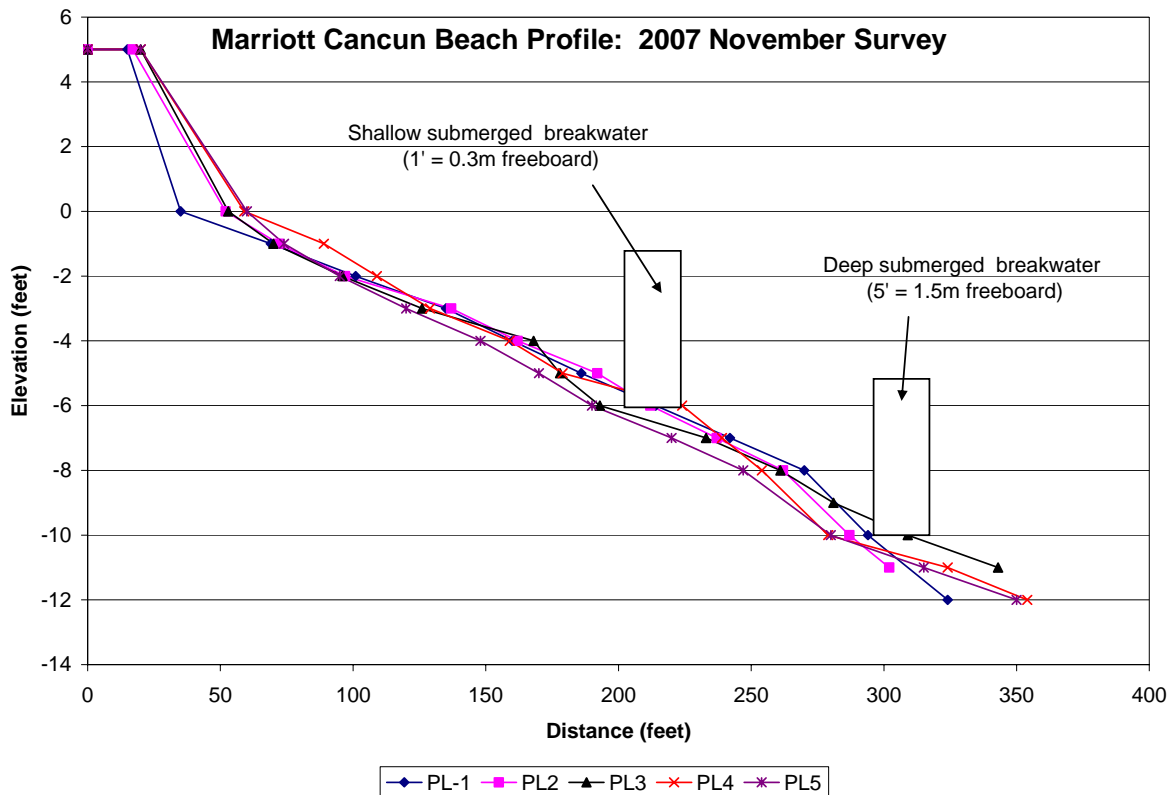
**Figure 13. Profile View of Proposed Submerged Artificial Reef Breakwaters**  
Two alternative locations are shown for 1.5m = 5' high breakwaters.

Possible locations of an offshore breakwater for the Marriott Resorts are shown in Figure 13. To be effective in wave energy reduction, the submerged breakwaters will need to be much wider than an equivalent emergent breakwater. A width of 33' = 10m or more may be necessary to provide the desired wave attenuation. For a narrow structure, the overtopping may produce ponding of water in the lee of the structure, which can create rip

The deeper breakwater location shown in Figure 13 is similar to the location of the submerged offshore geotextile breakwaters that have been proposed for the northern and southern areas of the eastern Cancun shoreline. The water depth of 1.5m above the breakwater has been proposed so as not to create a hazard to navigation, but a breakwater submerged that much will be less effective at wave energy reduction compared to a shallower breakwater.

The shallow breakwater location shown in Figure 13 is also shown in the plan view in Figure 14. With the shallow water depth = 1 foot = 0.3m above the structure, it would be much more effective in reducing wave energy, but would need to be marked with buoys (although located only 160 feet = 50m offshore is landward of boat traffic).

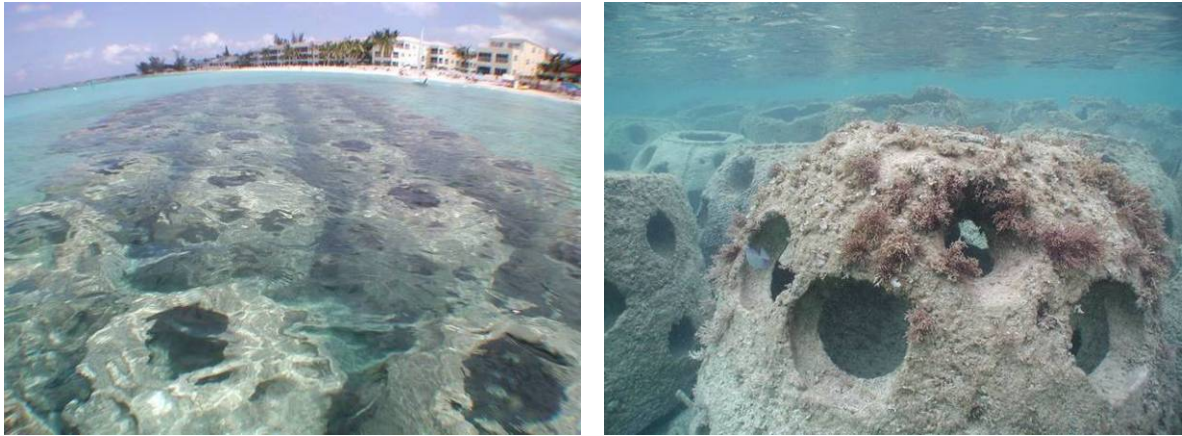
**Figure 16. Grand Cayman Marriott Five-Row Reef Ball Submerged Breakwater**

Figure 16 shows the 5-row reef Ball that was constructed offshore of the Marriott on the west coast of Grand Cayman in 2002. This system has stabilized the beach, and provides environmental enhancement and a snorkeling attraction for the tourists. The before and after

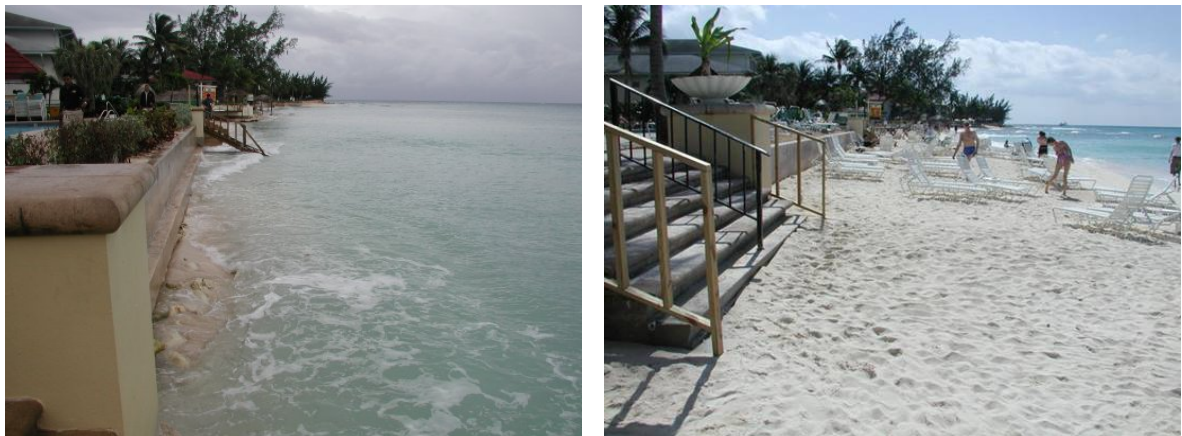
**Figure 17. Grand Cayman Marriott before and after Reef Ball Breakwater Installation**  
Fall 2002 on the left, February 2003 on the right.

photographs shown in Figures 17 and 18 show the successful beach stabilization, even with Hurricane Ivan impacting the area in 2005 and other wave impacts from more distant storms.
